[概要] ~OVERVIEW

Due to the typhoon on Sept.19, 2016, a large sinkhole occurred in a potato field of Miyakonojo, Miyazaki, leading to a soil outflow of 1500m³ to the road nearby. Fortunately, there were no human casualties, but sinkholes may lead to serious accidents depending on the time and place of occurrence. Therefore it is important to investigate the cause and take measures to prevent these accidents. Surveys including dynamic cone penetration tests and surface wave surveys were conducted to understand the cavities, waterpaths and loosening of underground.

平成28年9月19日の台風16号による影響で、宮崎県都城市で大規模陥没孔が出現した。陥没は五十町IC付近の畑に発生し、志布志道路に1500m³の土砂流出が生じた。今回は人的被害はなかったものの、地盤陥没は発生箇所や発生時間帯によって人的被害を伴う事故に繋がる可能性があるため、その未然防止のためにも発生原因を解明し必要に応じて対策することは重要である。本報では、陥没孔周辺の地盤のゆるみ、地下空洞、及び水みちの把握を目的として実施した簡易動的コーン貫入試験、表面波探査の結果について報告する。

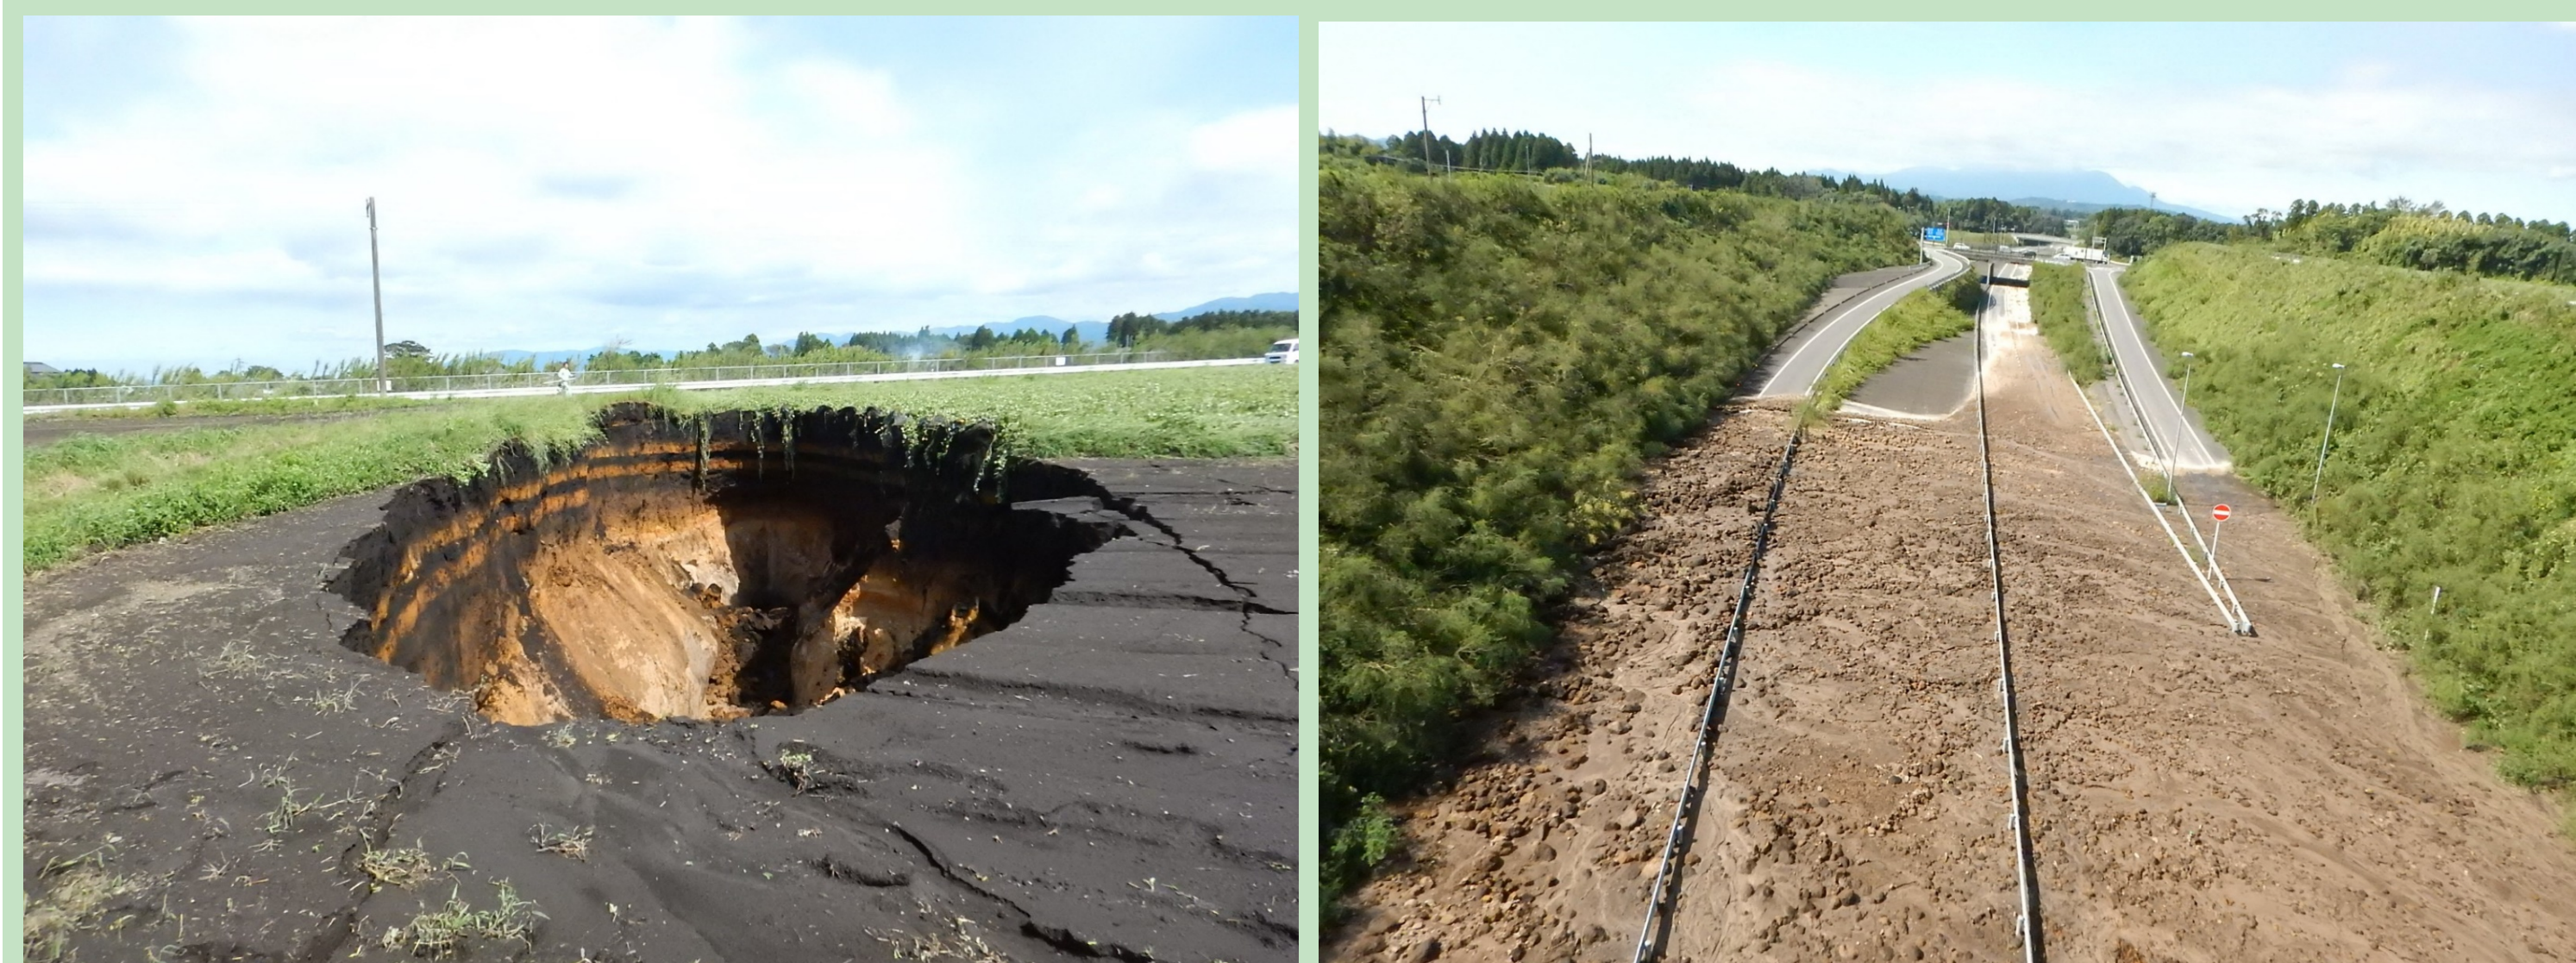
発生地と土砂流出の様子 Sinkhole and its outflow

・延長31m,幅13m,深さ7mの半楕円体の形状 Length..31m Width..13m Depth..7m
 ・陥没発生地はシラスによって形成されている台地状の地形で、普通の畑に比べて雨水浸透が速いと言われている。陥没容積は報告された土砂流出量とおよそ一致する。
 Sinkhole area is a Shirasu plateau, and it is said that the field's permeability is high. Soil outflow was reported as 1500m³, which matches with the estimated volume of the sinkhole.

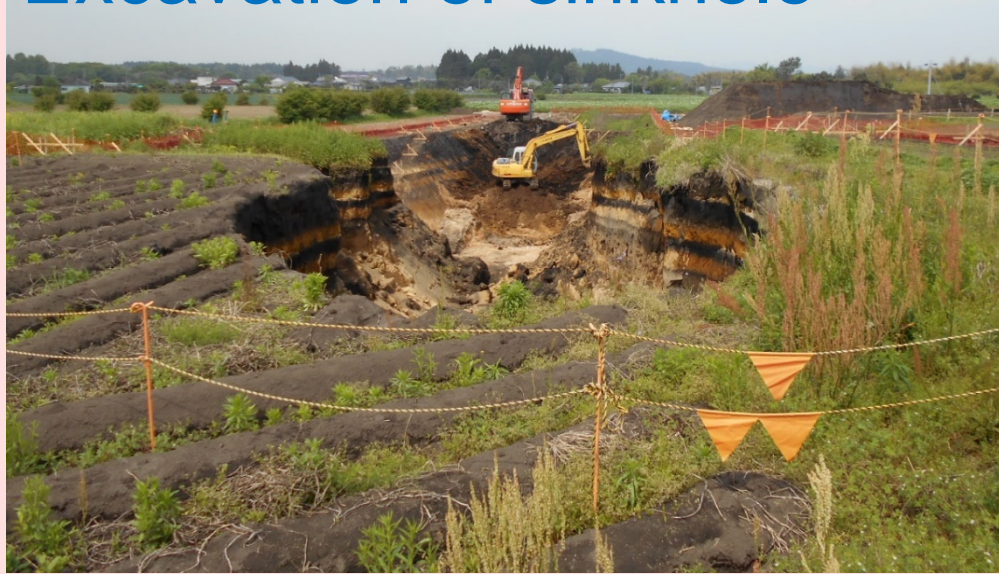
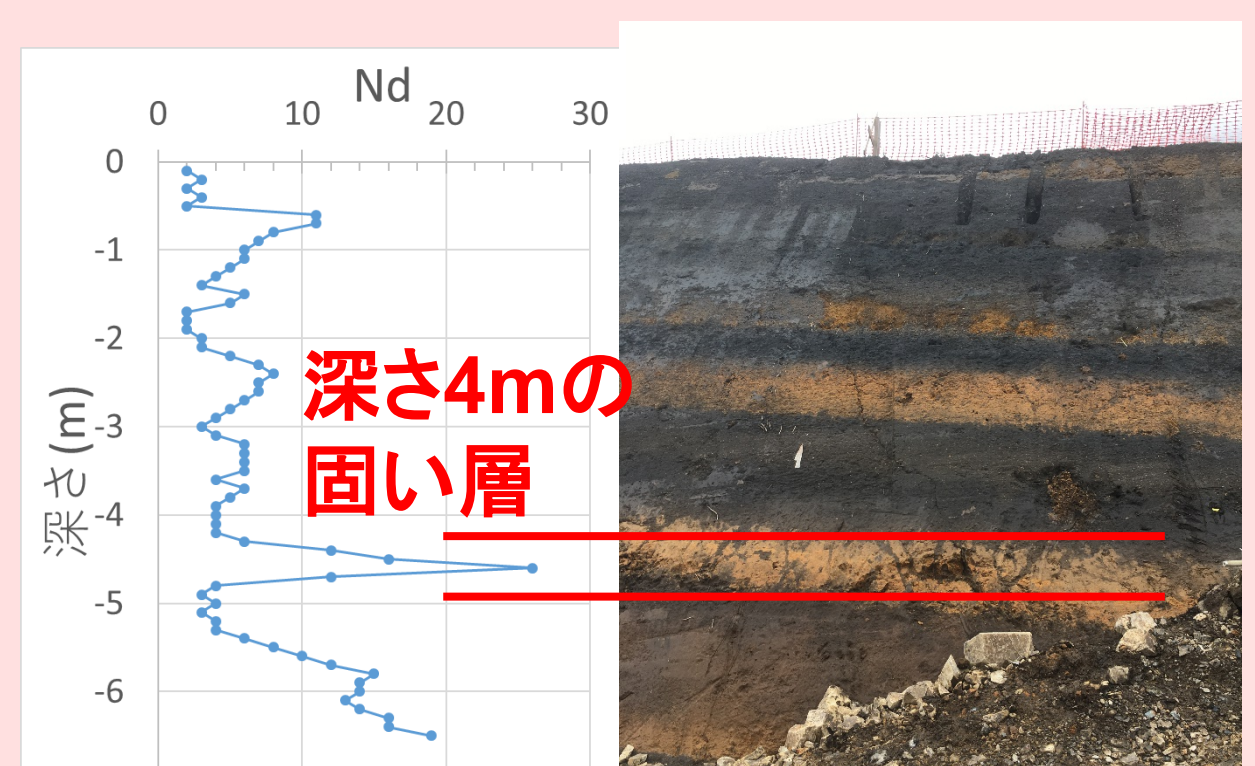
掘削の様子 Excavation of sinkhole

追加調査 復旧工事による掘削ため、より詳細な地盤の様子が把握された Excavation of sinkhole due to restoration work was conducted

- 深さ4mの固い層の特定
- 工事中に固い層の下に空洞が発見された
- 雨水による侵食が起きる層も見られた

- ✓ Hard layer at 4m depth was confirmed
- ✓ Cavities under the hard layer were found during the excavation
- ✓ Layers apt to erode were also confirmed
