Piping, known as a complex phenomenon of internal erosion, presents a great risk for hydraulic structures. In order to investigate the mechanical properties of sand with internal pipes, artificial piping was created by dissolving glucose column in a hollow cylindrical specimen of Toyoura sand. In this research, triaxial compression(TC), triaxial extension(TE) and torsional shear(TS) tests were conducted on specimens with vertical pipes before shearing. Piping propagation during water infiltration was observed with Glip Gauges, and gap sensors were used to obtain shear modulus before and after piping effect by conducting small torsional cyclic loadings. Finally, monotonic torsional shear were applied to all the specimens until failure.

盛土や斜面に繰返し雨水が浸透することにより土粒子が流出しパイプ状の水みちができる場合があり、ソイルパイプと呼ばれる。浸透した雨水を速やかに排水する効果が期待されるものの、何らかの理由で水みちが閉塞された場合は一転して危険であるうえ、土構造内に空隙を有することになり構造上の弱点となりうる。本研究では、中空ねじり試験供試体内にグルコースを溶解させることにより人工的なパイプ生成を試み、供試体の変形強度特性に対するパイプの数や拘束圧、土の密度の影響を調べた。

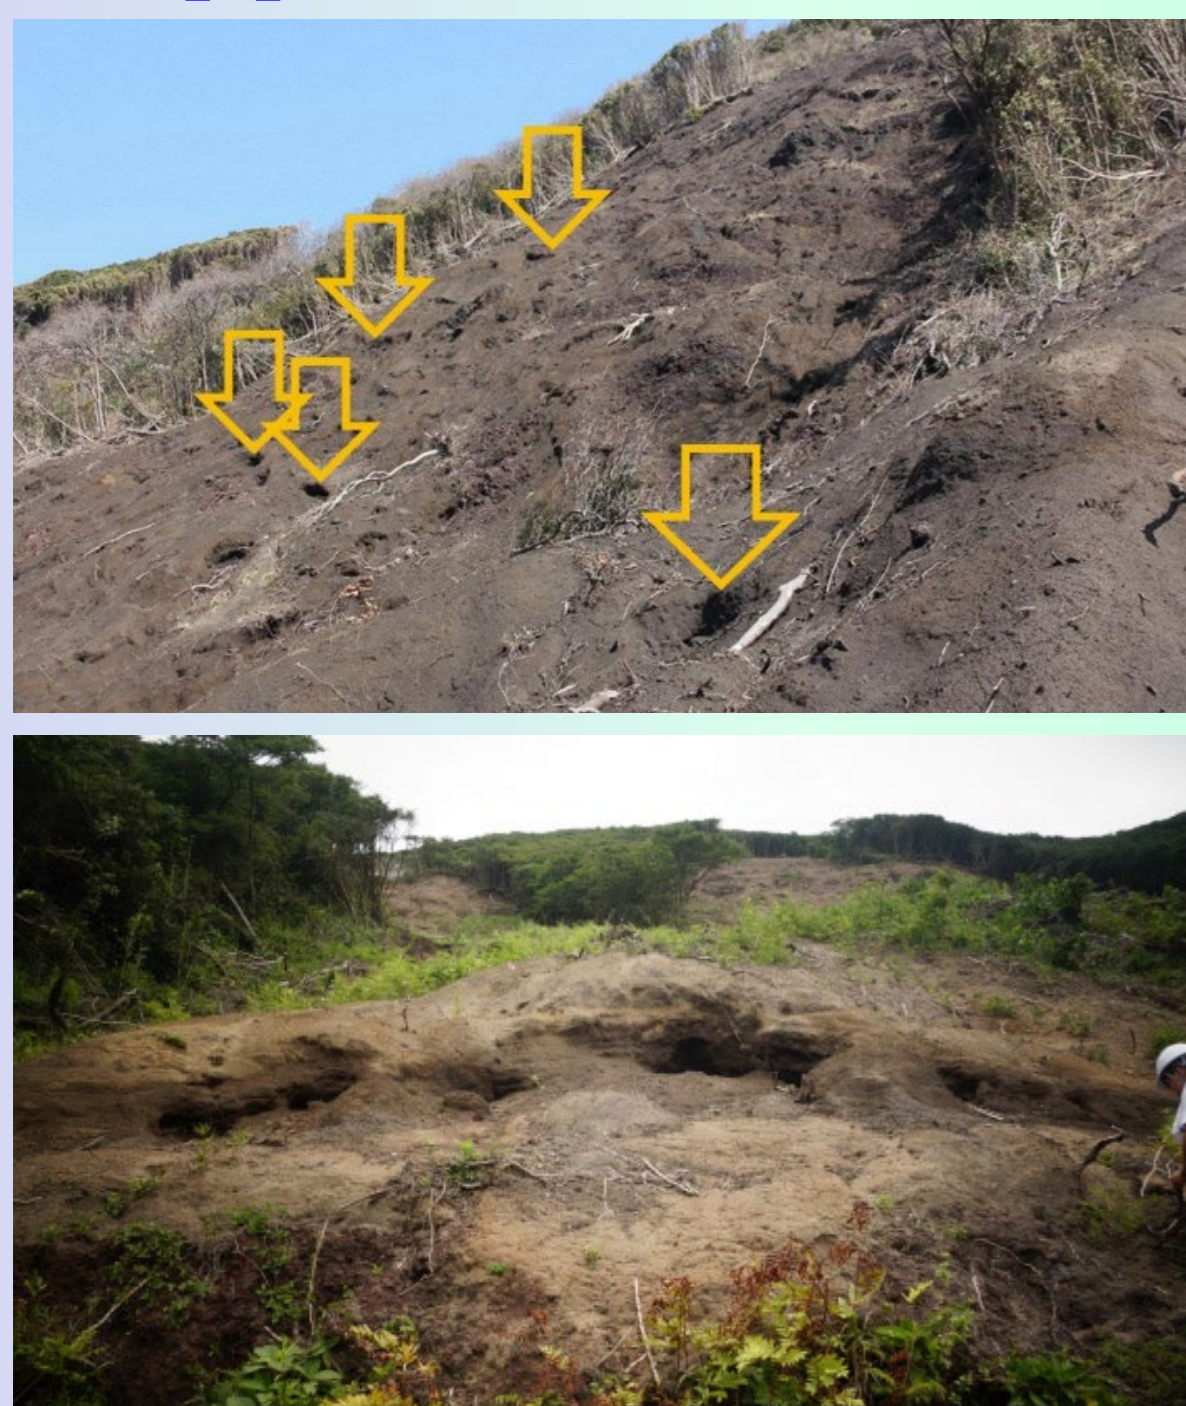
- ❖ Piping, which often occurs in hydraulic works, involving the removal of subsurface soils in a continuous tunnel to a free or escape exit.
- ❖ Landslide caused by piping has drawn much attention recently.

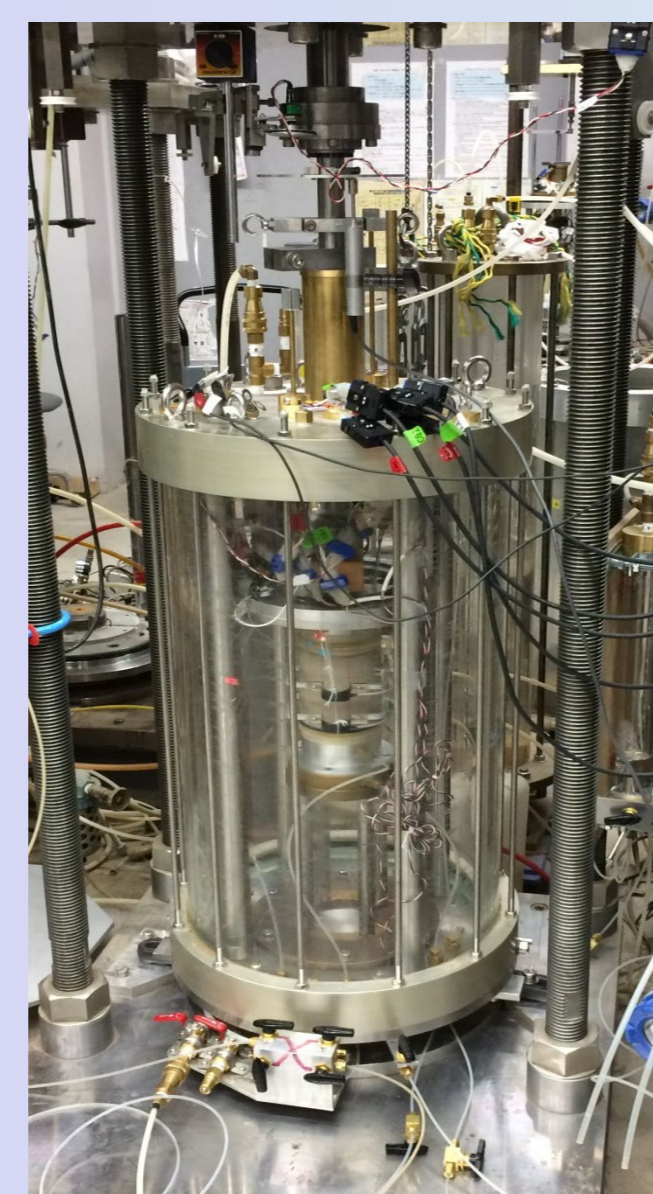
Hollow cylindrical torsional shear apparatus

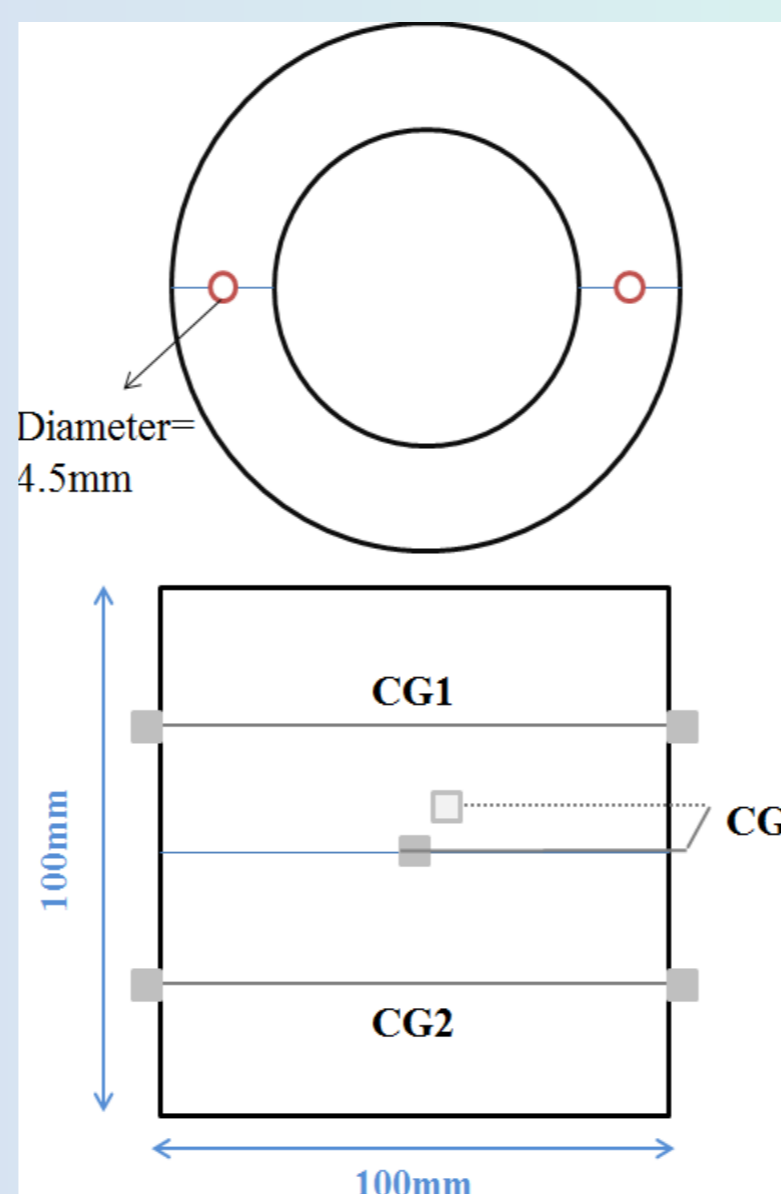
Arrangement of Clip Gauges (Radial strain measurement)

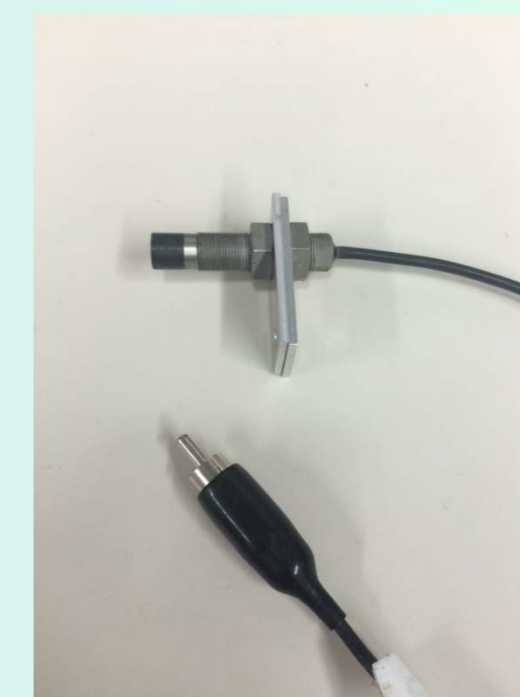
Gap Sensor (Shear modulus measurement during small torsional cyclic loadings)

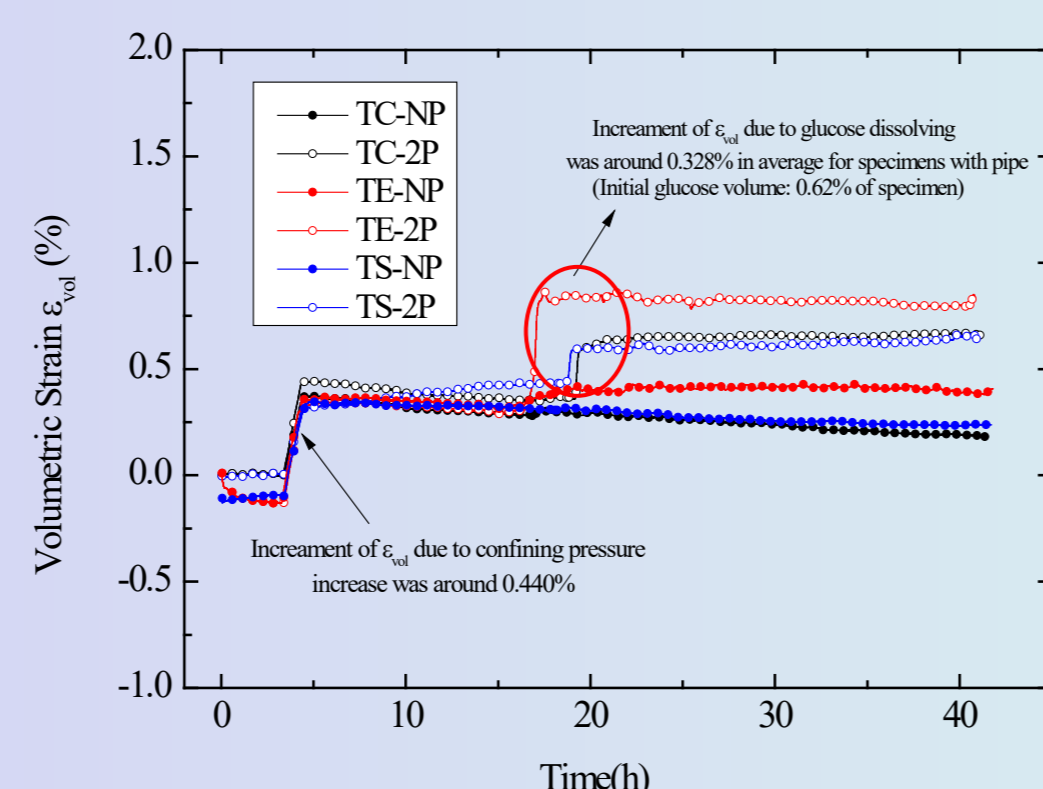
Volumetric strain variation before shearing

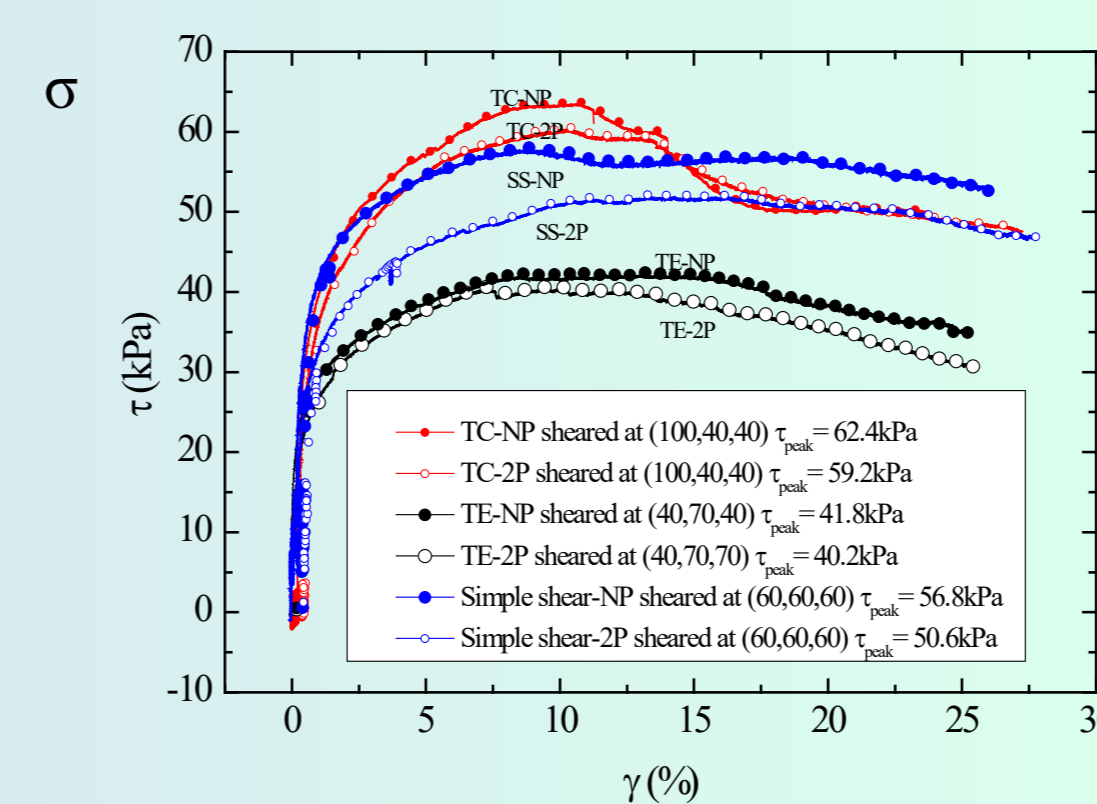
Shear stress vs. shear strain

- ❖ Internal erosion in the form of piping was successfully created in sand by glucose power.
- ❖ Decrease of shear modulus  $G$  was observed in specimens subjected to piping effect.
- ❖ Shear starting from triaxial compression showed the highest resistance while triaxial extension the lowest. Larger difference of peak shear strength between specimen with and without pipe was found at simple shear test.
- ❖ For  $G$  measured during TE,  $n$  computed from the function of  $G \sim (\sigma_z \sigma_r)^{0.5n}$  was not normal possibly due to the limitation of the data number. Still, more degradation was observed in specimen subject to piping effect.

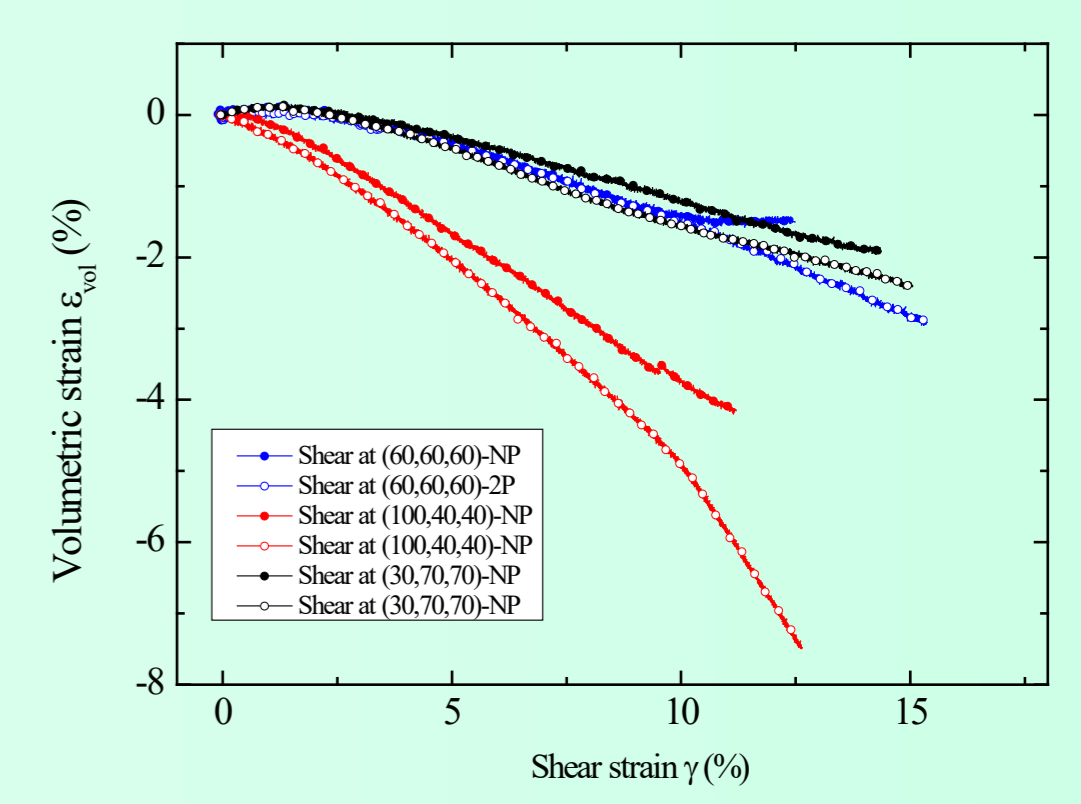
Volumetric strain during shearing

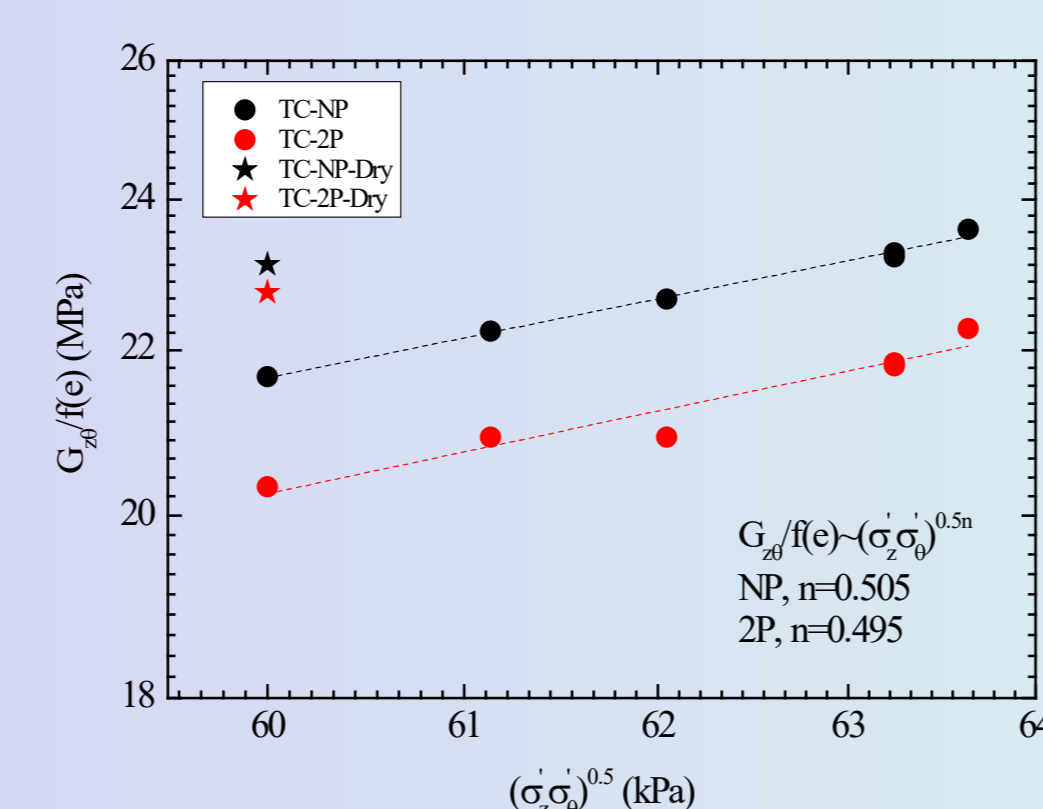
Shear modulus variation during triaxial compression

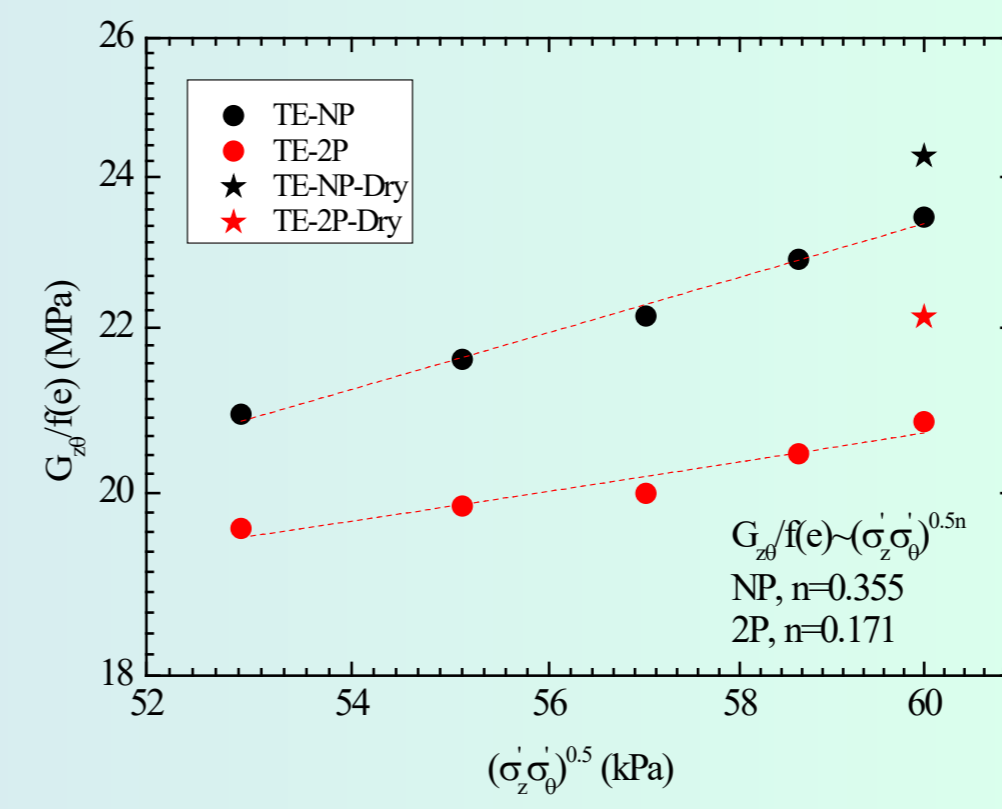
Shear modulus variation during triaxial extension

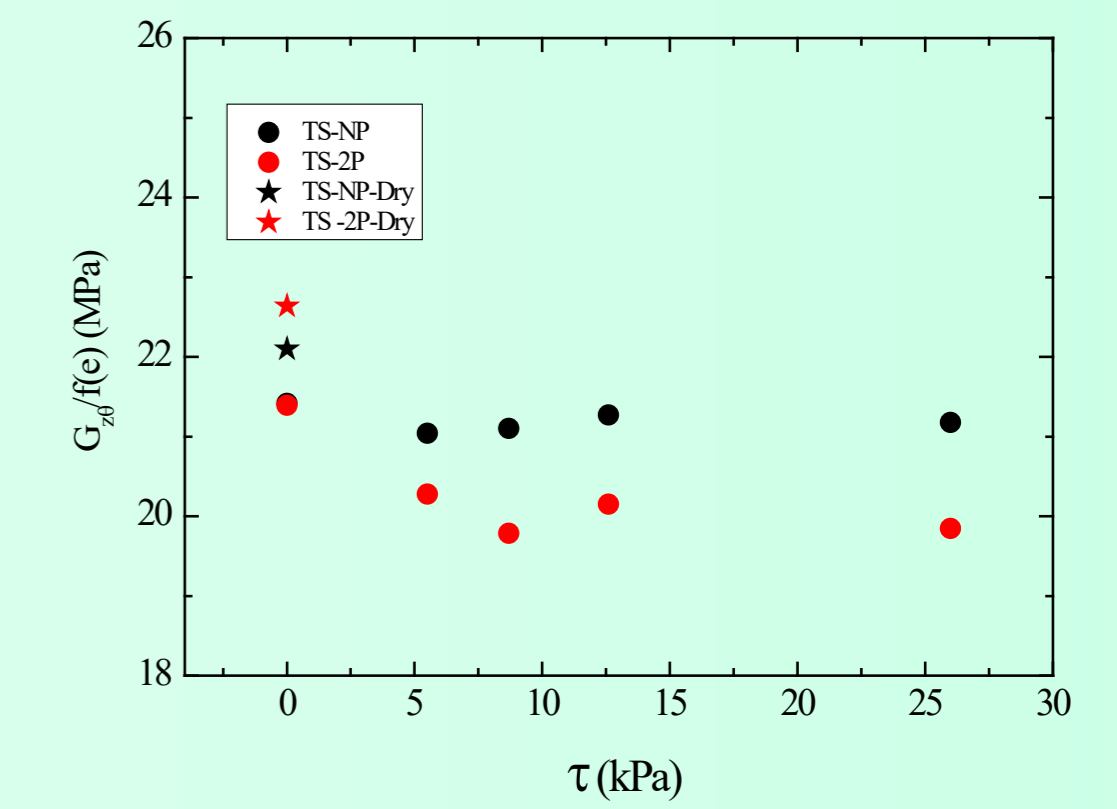
Shear modulus vs. Shear Strength
