## 宮崎県都城市の陥没発生地における地盤調査

小南直翔 (2017)

### [概要] ~OVERVIEW

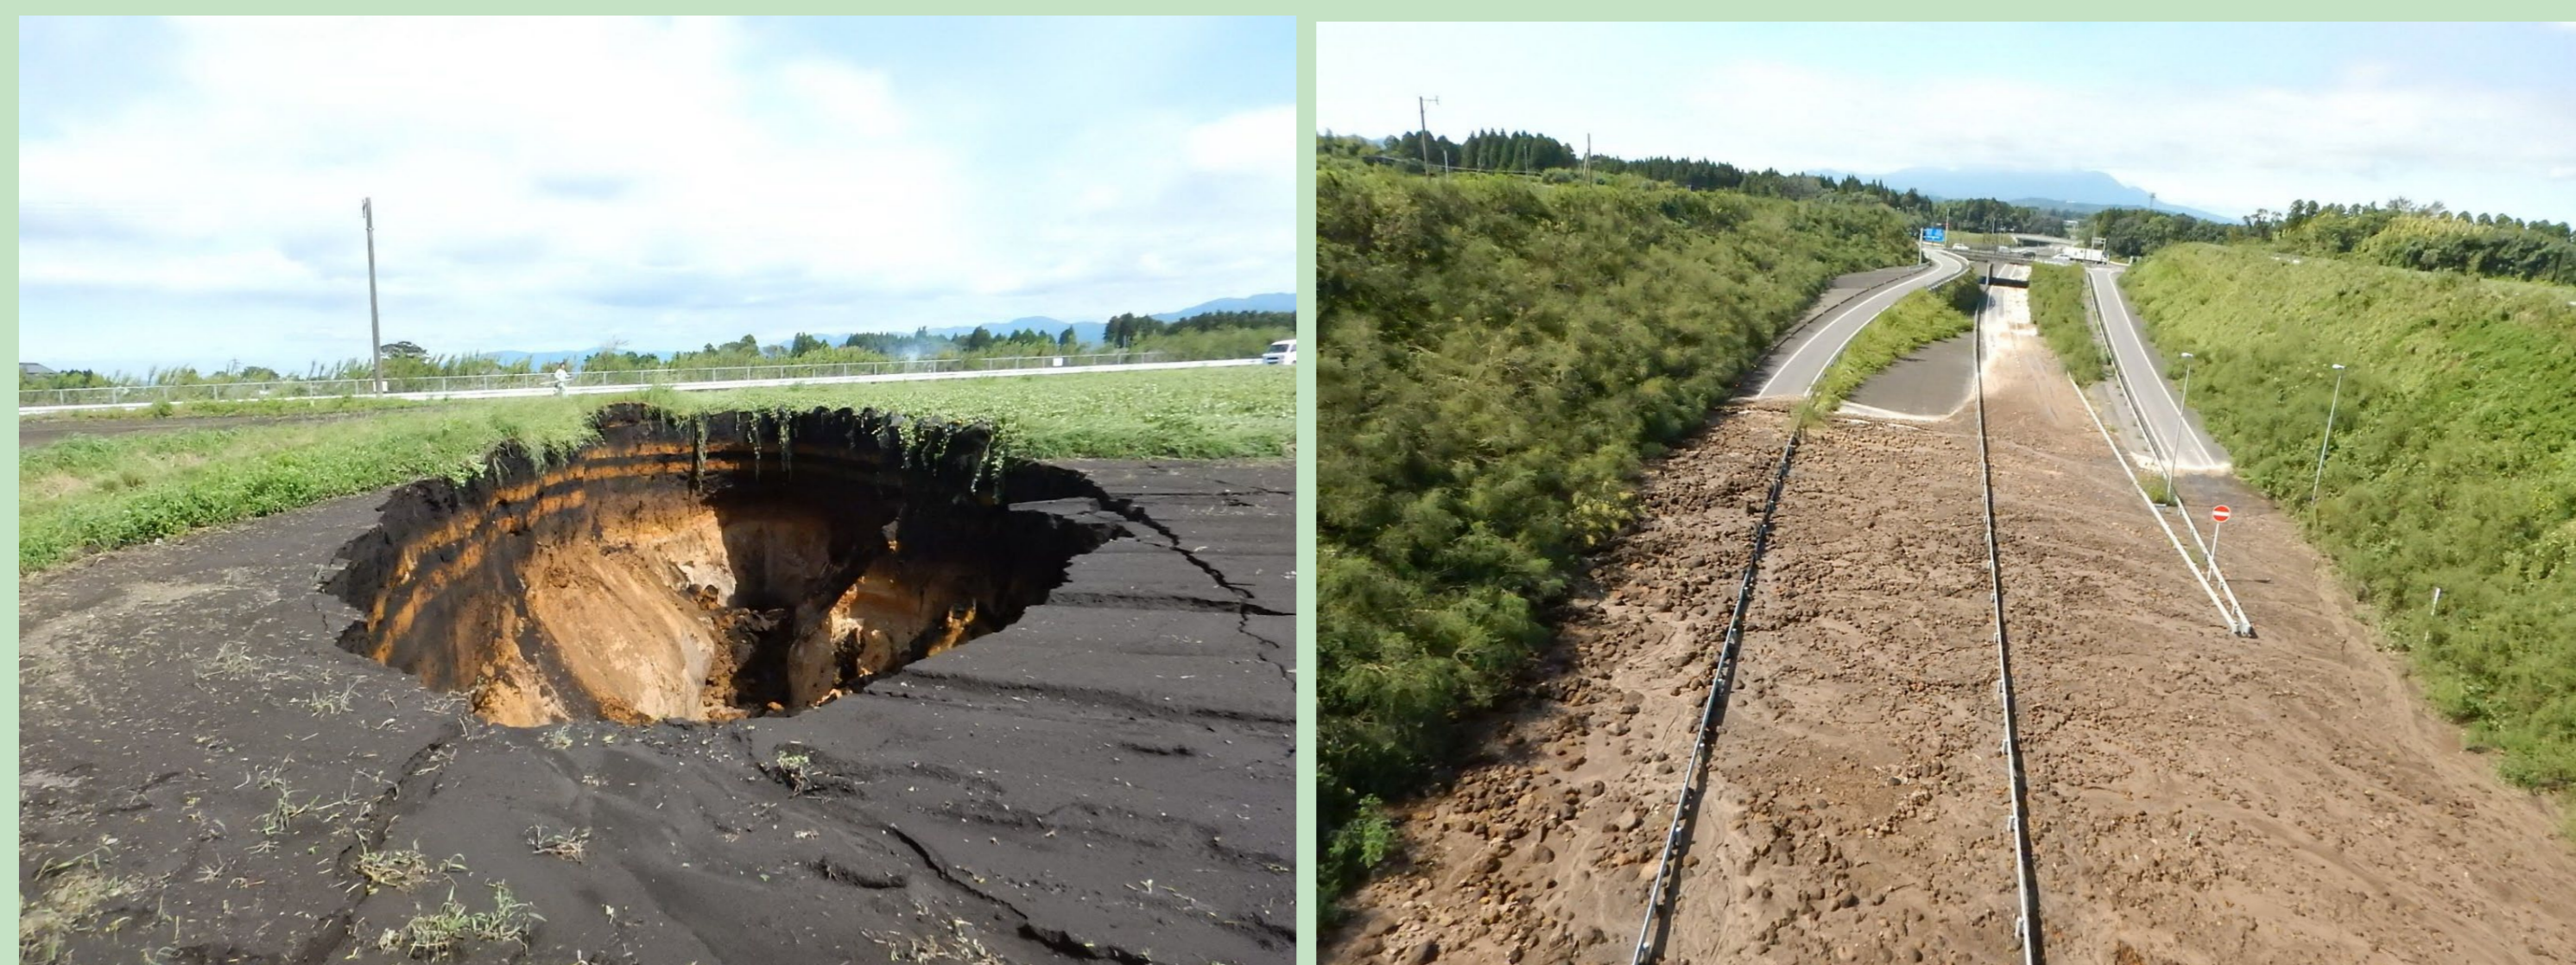
#### 発生地と土砂流出の様子 Sinkhole and its outflow

・延長31m,幅13m,深さ7mの半楕円体の形状 Length..31m Width..13m Depth..7m  
 ・陥没発生地はシラスによって形成されている台地状の地形で、普通の畑に比べて雨水浸透が速いと言われている。陥没容積は報告された土砂流出量とおよそ一致する。  
 Sinkhole area is a Shirasu plateau, and it is said that the field's permeability is high. Soil outflow was reported as 1500m<sup>3</sup>, which matches with the estimated volume of the sinkhole.

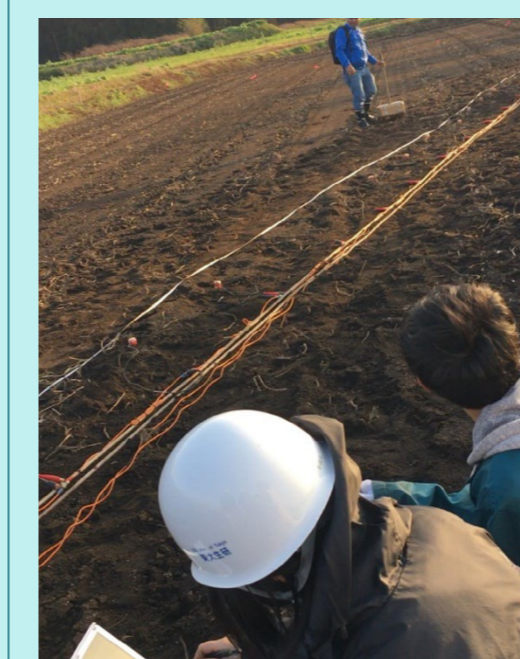
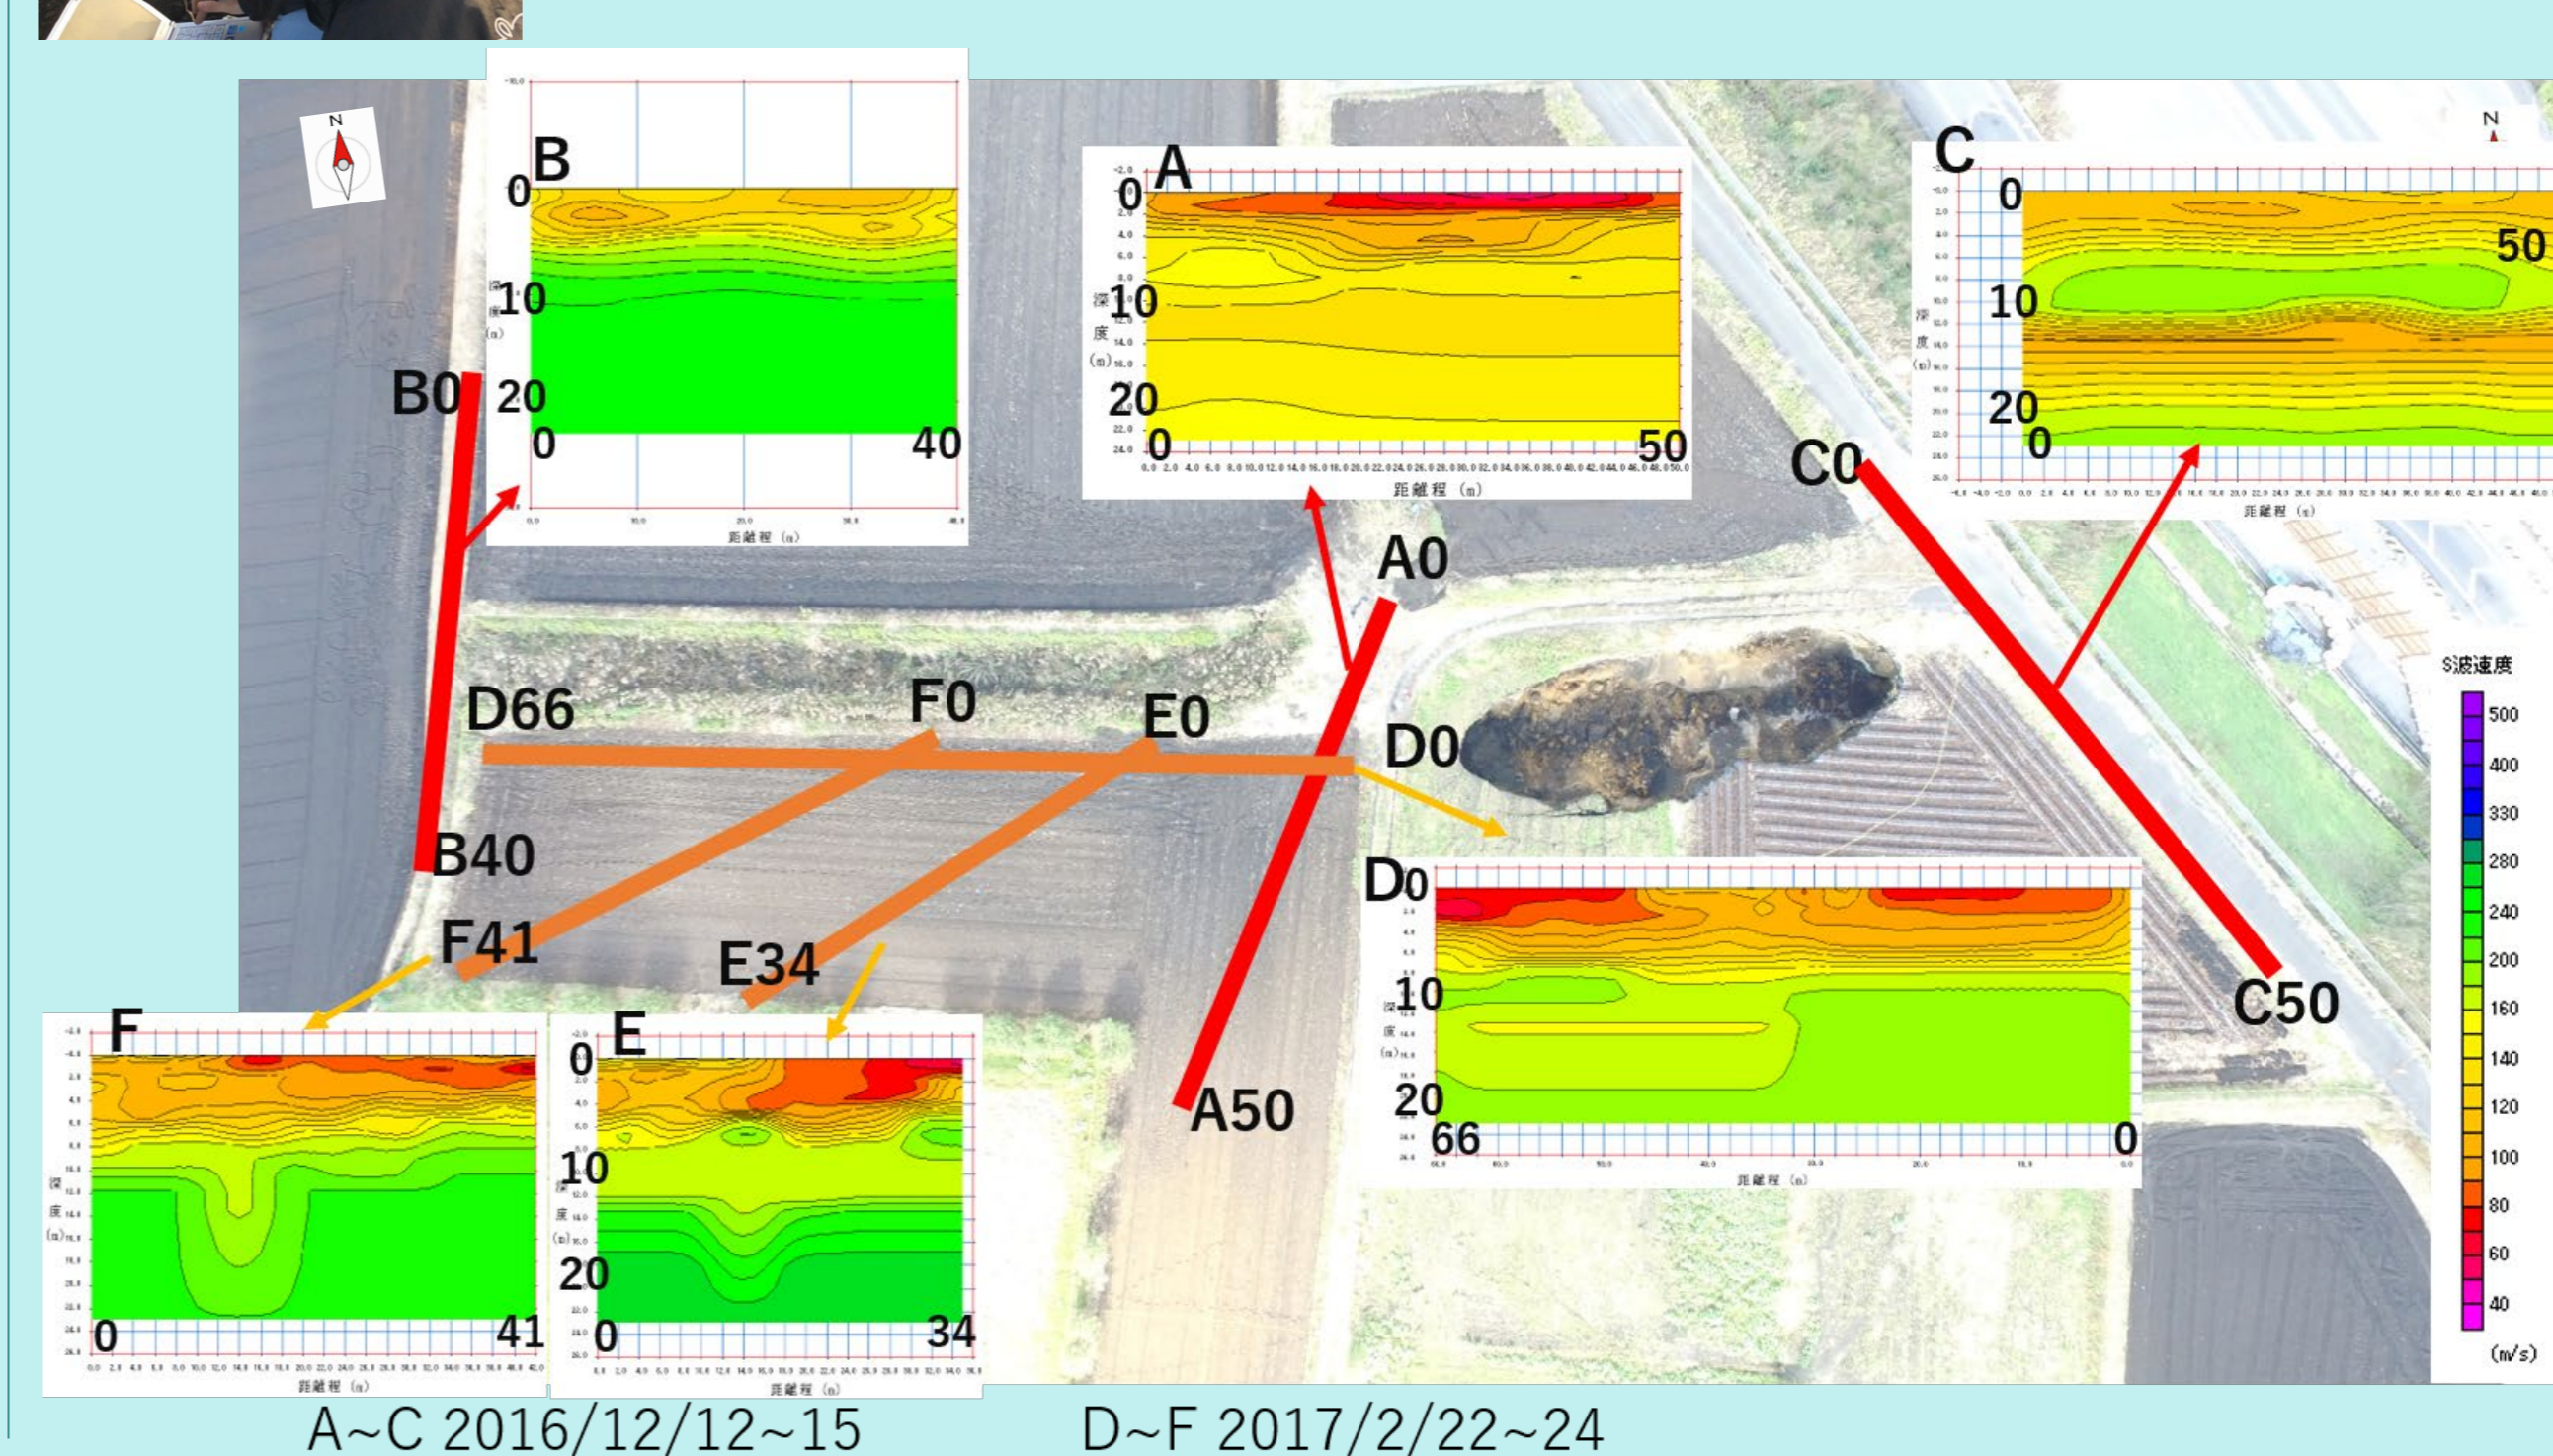
#### 表面波探査試験 Surface wave survey

波を起こして伝播速度から地盤のゆるみを測定

- 陥没西側のA測線の10m付近に弱部
- D測線の西側に目玉のようなゆるみ
- ✓ Weak layer around 10m depth of line A
- ✓ Loosening at the west side of line D

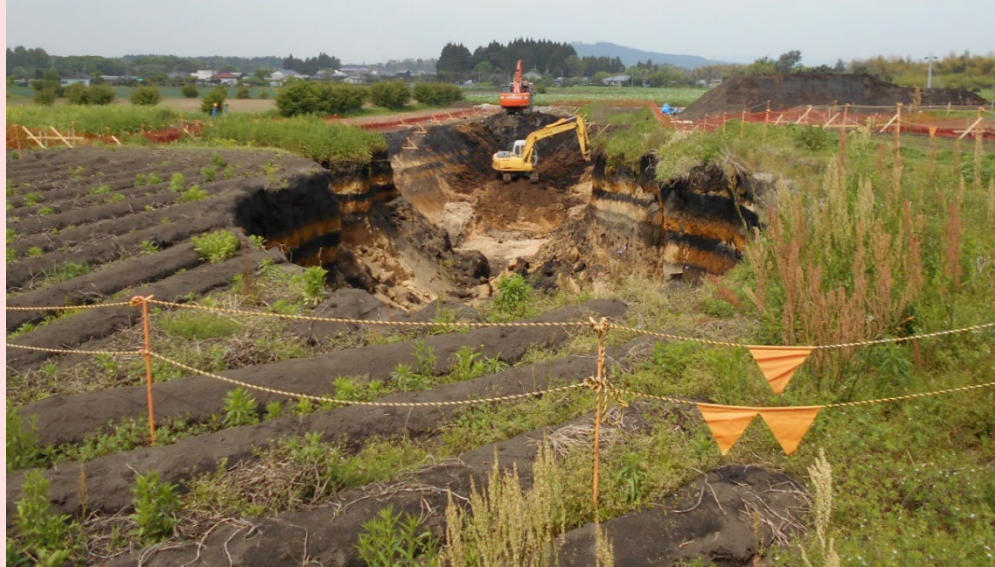
##### 掘削の様子 Excavation of sinkhole

#### 追加調査 復旧工事による掘削ため、より詳細な地盤の様子が把握された Excavation of sinkhole due to restoration work was conducted

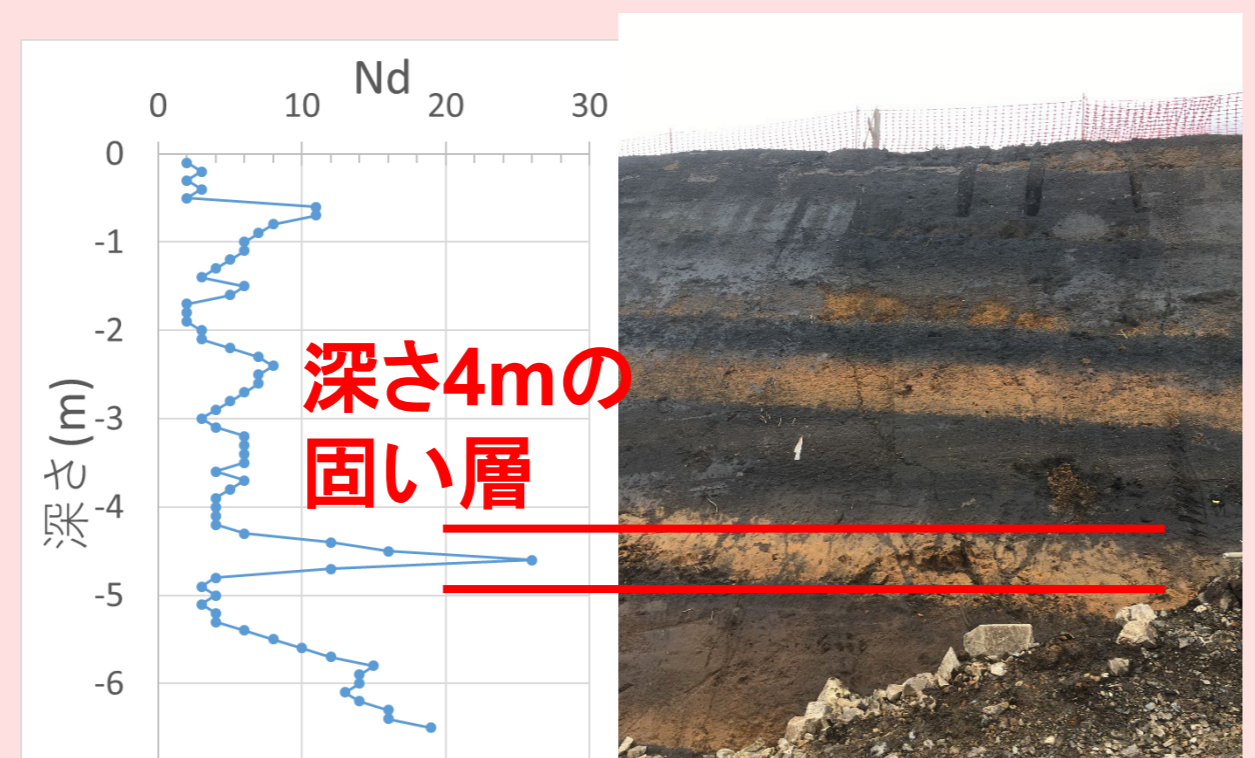
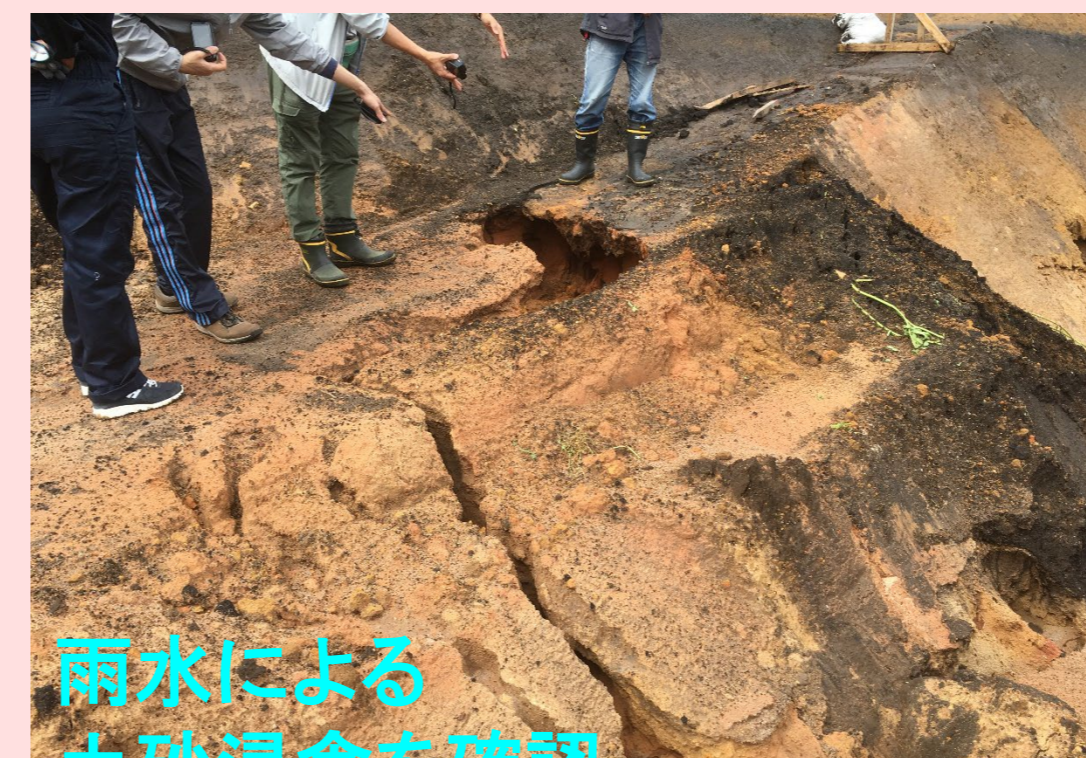
2017/5/12~14

雨水による土砂浸食を確認

- 深さ4mの固い層の特定
- 工事中に固い層の下に空洞が発見された
- 雨水による侵食が起きる層も見られた

- ✓ Hard layer at 4m depth was confirmed
- ✓ Cavities under the hard layer were found during the excavation
- ✓ Layers apt to erode were also confirmed
